Manhole Inspection Summary

Manhole # S53C__031MH

Insp Date: **6/20/08 12:51 PM**

Location Address: **rear 3404 e baltimore st**

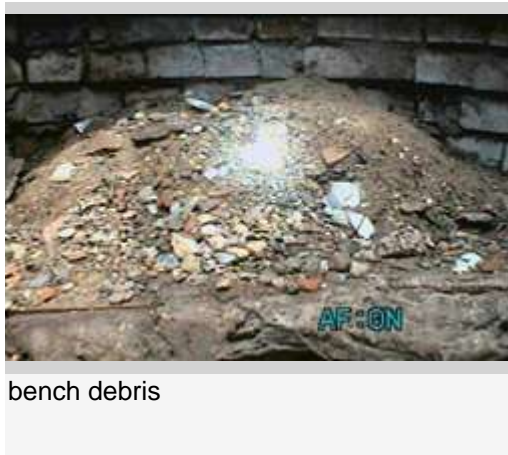
Defect 4

Condition: ☐ Sound ☐ Cracked ☐ Root Intrusion ☐ Deteriorated ☐ Leaks ☒ **Debris**

bench debris

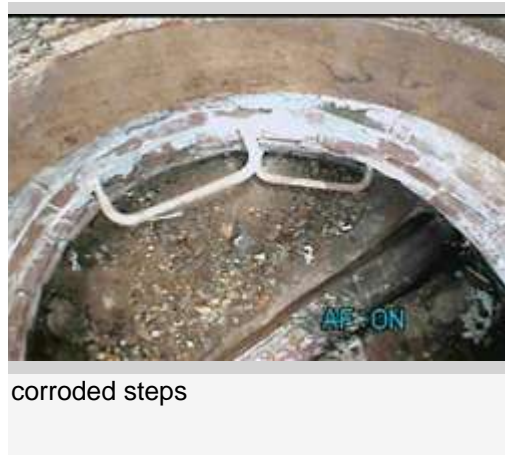
Defect 3

Steps Count: **2** Missing: **0** ☒ **Corroded**

corroded steps

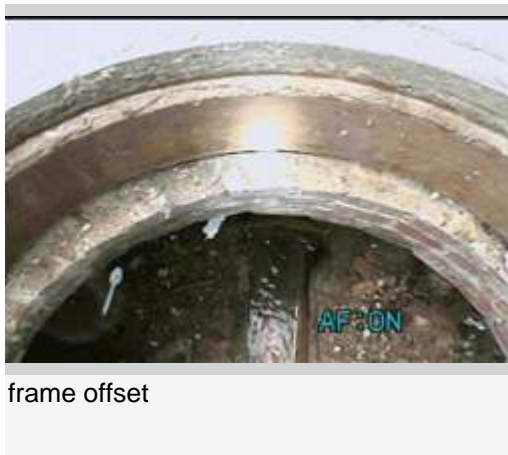
Defect 2

Frame Offset: **2** (in.) Condition: ☒ Sound ☐ Cracked ☐ Leaks

frame offset

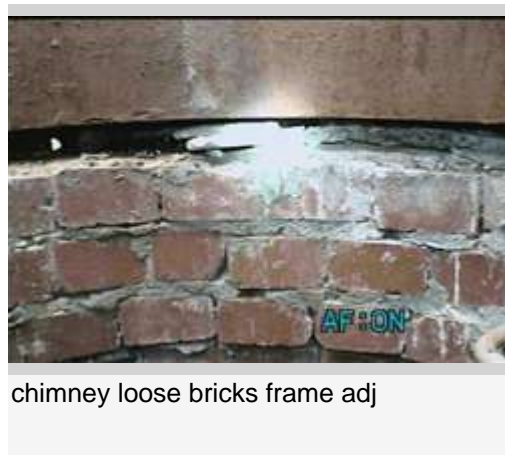
Defect 1

Condition: ☐ Sound ☐ Cracked ☐ Root Intrusion ☒ **Loose Brick** ☒ **Deteriorated**

chimney loose bricks frame adj

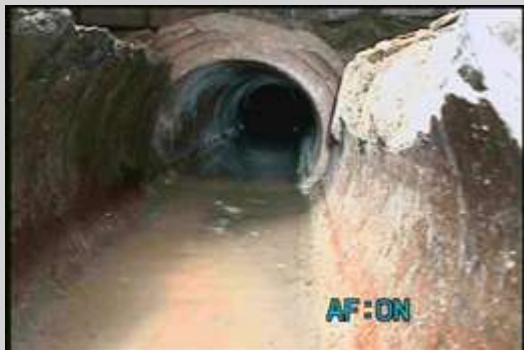
12 O'Clock Outflow

Invert Depth: **4.97** (ft.) Flow Characteristics: **Fast**

Deposits: ☒ None ☐ Mud ☐ Sludge ☐ Debris ☐ Grease

Infiltration: **None**

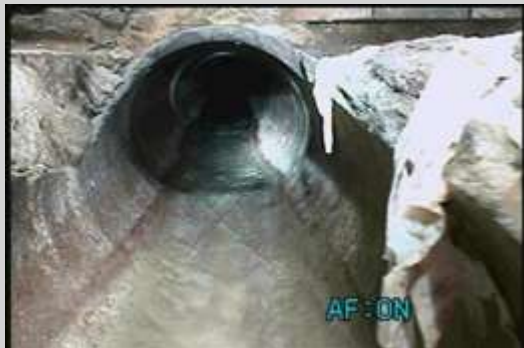
6 O'Clock Inflow

Invert Depth: **4.95** (ft.) Flow Characteristics: **Fast**

Deposits: ☒ None ☐ Mud ☐ Sludge ☐ Debris ☐ Grease

Infiltration: **None**
